PLASTIC PACKAGE AVAILABILITY (PPA) PROGRAM

National Semiconductor Corp.

Final Technical Report for Period October 1992 - November 1995

November 1995

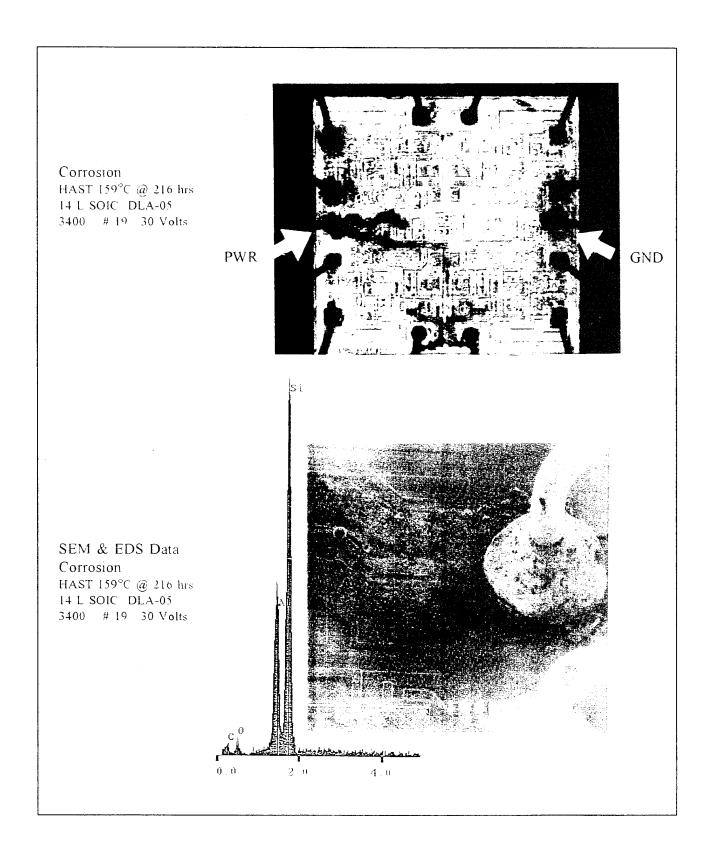
Figure 7

Taken from F/A report, Section 9. Shows gross corrosion on bond pads and circuit metallization after 216 hrs. of HAST at 159°C.

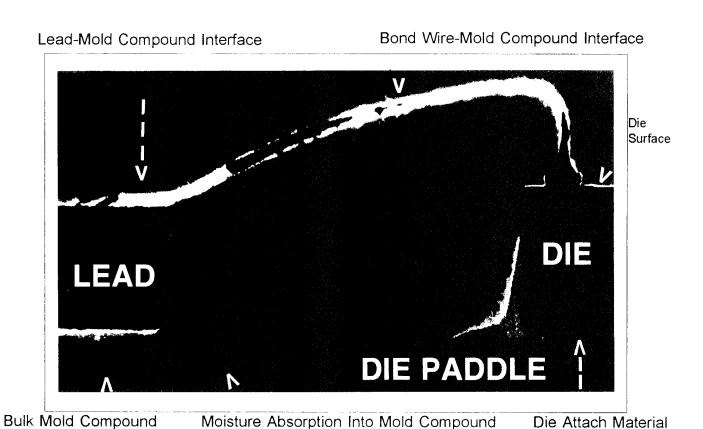
Figure 13

Shows complex materials and interfaces, comprising the structure of the LM124 14L - SOIC. These interfaces and materials can provide paths and sources for moisture and contamination during the life of the device.

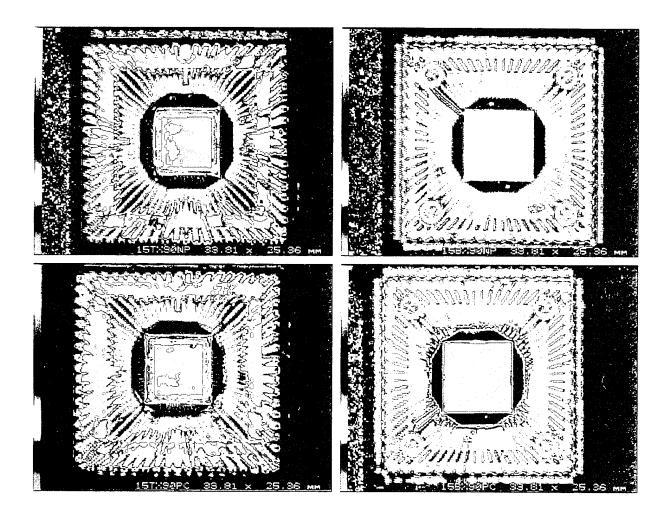
Figure 14 PRECONDITIONED

Shows delamination on the underside of the paddle on preconditioned 68L - PLCC. The Topside appears to be only marginally affected, if at all.

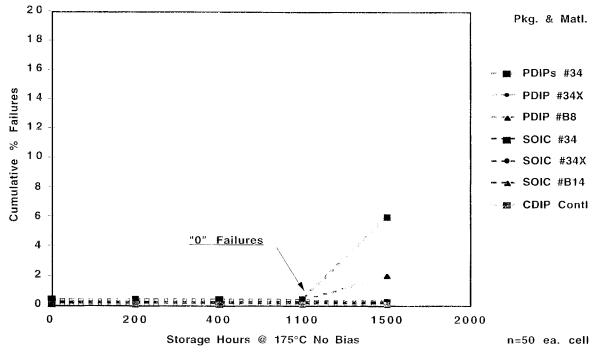
Figure 23

Figure 23, High Temperature Storage Performance of LM124 Plastic ICs: DIP vs. SOIC, shows the few failures (for the room temperature readout testing used, 4/150), that were generated for the HTS for all of the LLC plastic. It was assumed the same intermetallic mechanism existed in these LLC devices and due to time limitations, no 125 °C testing nor further failure analysis was performed.

High Temperature Storage Performance of LM124 Plastic ICs @ 175°C with Preconditioning: DIP vs. SOIC

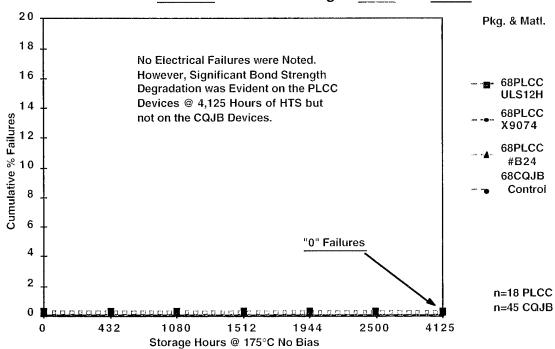
Figure 25

Figure 10 shows the formation of gold-aluminum intermetallic at the gold ball-aluminum bondpad interface of a <u>non-failed HLC</u> device after 4125 hrs. of high temperature storage. No failures were generated by HTS as shown by the graph in Figure 25, High Temperature Storage @ 175 °C for PLCC vs. CQJB, for the standard room-temperature electrical readouts; however, when the same devices were tested at 125 °C, 26/47 showed gross-functional failure. The results of the 125 °C test by mold compound showed the X9074 anti-popcorn to be far superior to the other compounds for passing gross functional: (see Table 4)

High Temperature Storage of 4.4K Gate Arrays @ 175°C without Preconditioning: PLCC vs. CQJB

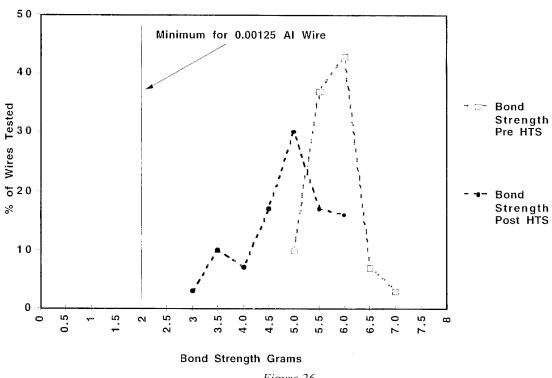
Figure 26

Figure 26, Affects of Wire Bond Strength in CQJB: PRE HTS vs. Post HTS, shows plots for the aluminum-aluminum bond strengths of the hermetic-ceramic control CQJB from the HTS test. Although the CQJB bond strengths have somewhat degraded they are still well above the minimum for the aluminum wire used. Figure 11 shows a cross-section through this aluminum-aluminum bond system, which is used in most hermetic-ceramic packages, for comparison to the gold-aluminum system of Figure 10, which is used in most plastic devices. As expected, no signs of an intermetallic are observable in the aluminum-aluminum bond cross-section of Figure 10.

Affect of 175°C HTS on Wire Bond Strength in CQJB: PRE HIS vs. Post 4,125 Hours HTS

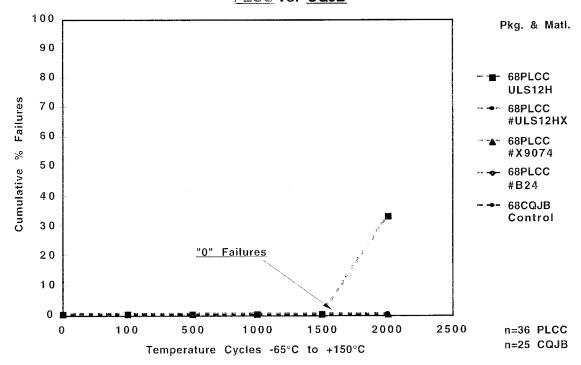
Figure 29

Figure 9 (top photo), shows evidence of dielectric stress cracking on a HLC plastic device after 2000 temperature cycles. One group only, of compound ULS12H, had any failures, 12/36, as shown in the graph of Figure 29, Temperature Cycle of PLCC vs. CQJB (for detail see Master HLC Failure Analysis Chart in Section 9). The LLC plastic had no failures, as shown graphically in Figure 24 for Temperature Cycle Performance of LM124 Plastic DIPs vs. SOICs, out to 1512 temperature cycles at which point the test was terminated for time constraints (for detail see Master LLC Failure Analysis Chart in Section 9). Cracks in the corners of the failed large dice topside dielectric passivation were evident when decorated w/KOH etching solution (underlying aluminum circuit traces etched away). Evidence of cracks did not exist for non-failed die from the other HLC TC test compounds, such as the X9074 compound (bottom photo in Figure 9). Dielectric stress cracking was 2nd most prevalent failure mode for the total DOE, although only affecting the HLC devices.

Temperature Cycle of 4.4K Gate Arrays: PLCC vs. CQJB

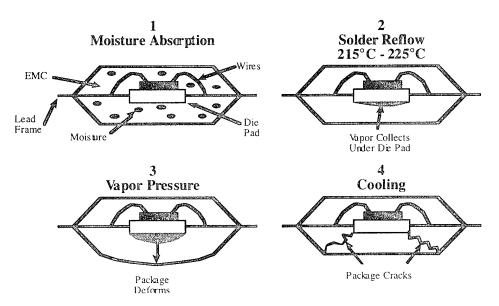
Fig 12

The mechanism of popcorn cracking is shown in Fig 12. A standard epoxy molding compound will typically absorb moisture up to its saturation point of 0.4-0.6%. During solder reflow, the moisture turns to steam thereby exerting pressure on the bottom of the die pad and plastic. This pressure causes bulging of the plastic which leads to package cracking.

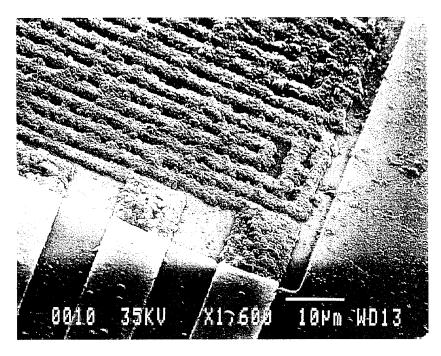
Fig. 20. SEM micrograph of decapsulated NAT-01 *unpassivated* CD that failed during HAST at 159°C/85% RH with 5 VDC bias between tracks. This part was molded in a 14-lead DIP using Plaskon 3400 molding compound.

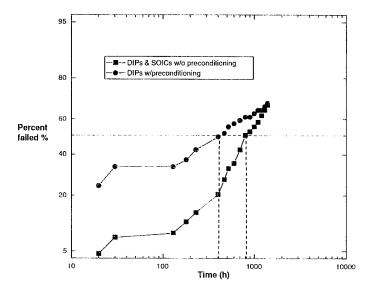
Fig. 21. NAT-01 passivated CD triple track failure distribution during HAST at 159°C/85% RH and 5 VDC bias on 14-lead DIPs and SOICs molded in Plaskon molding compounds. Plot is log-normal showing failures observed during off-line measurement intervals in a normal probability distribution as a function of log time. Non-preconditioned parts are shown as filled squares (\blacksquare), and preconditioned parts are shown as filled circles (\blacksquare). The preconditioned parts show a reduction in t_{50} of ~50%.

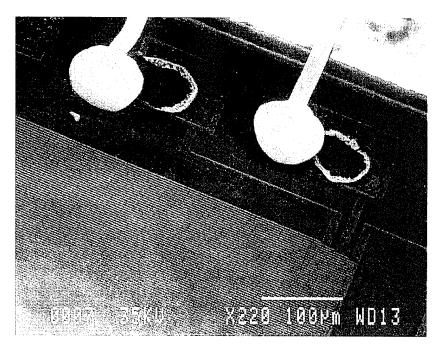
Fig. 22. Decapsulated NAT-01 test chip after 432 hours of HAST by Crane at 159°C/85% RH and 5 VDC bias, showing bondwire/bondpad voiding failure of the passivated CD. Bondwires were moved to the side for clarity. Note voiding in center of bondpads and lack of any signs of corrosion in the high field region of the triple track structure.

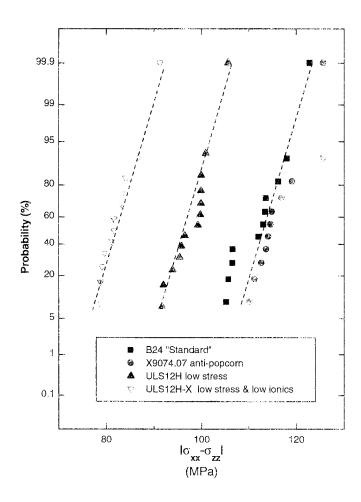
Fig. 27. Average in-plane compressive stress measured with ATC04 test chips molded in 68-lead PLCCs with Plaskon epoxy molding compounds. These data represent changes in stress state due to the die attach and molding operations.

The data in Fig. 27 show a clear trend toward decreasing compressive stress for the low stress formulations, but it was not immediately clear why the ULS12H-X material was so much lower than the ULS12H material. It is informative to predict the stress rankings for these materials using a "stress index" expression, $E\alpha(T_G-T_A)$, where E is the elastic modulus, α is the coefficient of thermal expansion, T_G is the glass transition temperature, and T_A is the ambient temperature. For the materials used in this experiment we get:

Using this stress ranking, we see that the distributions in Fig. 27 basically follow the same trend and, therefore, are in general agreement with expectations based on material properties. No delaminations were evident from C-SAM at this point or after subsequent thermal cycling.

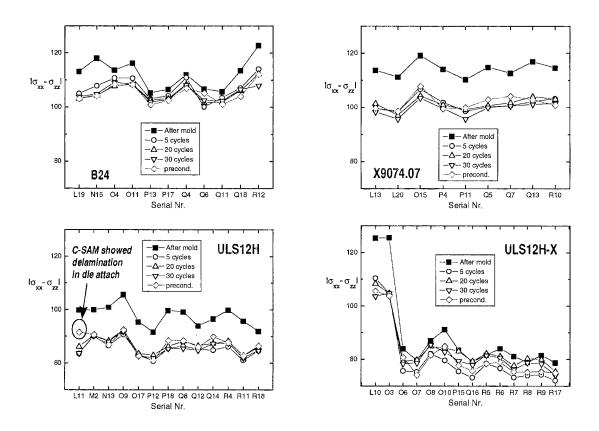
Fig. 28 contains plots of all the stress data recorded during the experiment. Each chart contains data for one of the four molding compounds, plotted as absolute compressive stress as a function of part serial number. Stress measurements underwent a shift in magnitude toward decreasing compressive stress after the first temperature cycle, but maintained the new stress reading through subsequent temperature cycling and IR reflow with the exception of one part –L11. This part, molded with the ULS12H material, had indications of die attach delamination after IR reflow in C-SAM and also a significant jump in average compressive stress reading.

Fig. 28. Average in-plane compressive stress measured by ATC04 test chips molded in 68-lead PLCCs during -65° to +150°C temperature cycle and ~240°C IR reflow simulation. Each data point represents the average of 25 stress cell readings on a single die. Plots are absolute compressive stress vs. part serial number. Symbols in all plots: after mold (\blacksquare), after 5 temp cycles (\bigcirc), after 20 temp cycles (\triangle), after 30 temp cycles (\bigcirc), and after IR reflow (\diamondsuit). Note general relaxation of stress after first temperature cycle across all molding compounds. The two outliers in the ULS12H-X chart are thought to be X9074.07 parts that were mismarked. Part L11 showed delamination of the die attach from C-SAM that correlated with an increase in compressive stress after IR reflow.

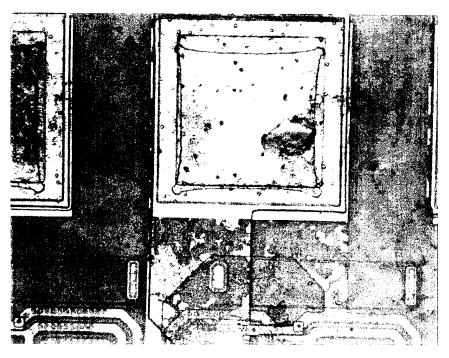
results, it is clear that the reliability of these devices have been compromised and no further reliability / life tests was performed on these test samples.

Figure 3. Appearance of the bond pad region after 4 hours of salt fog exposure.

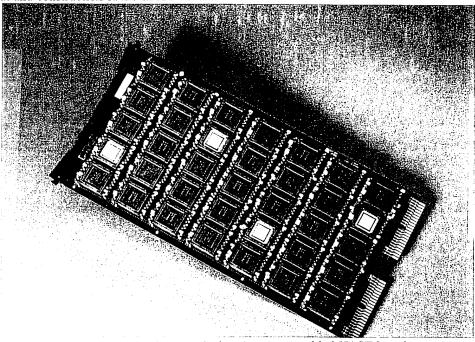
Initial supply problems of the HAST boards and associated resistors / capacitors plagued the start-up of the reliability testing. Although ceramic discrete components were specified for the board construction, plastic coated devices were assembled by the supplier (Trio Tech) which subsequently melted together, shorted, and became unusable during a 24 hour dry run at 159°C, 85% RH. Replacement ceramic discrete components were procured and used for the actual HAST reliability testing. In addition, the sockets used to bias the PQFP also shrunk slightly after the first 24 hour run through the HAST exposure. Both the original discretes and the sockets are reported to resist prolong autoclave conditions (121 °C, 100%RH) and high temperatures (200 °C). However, having both conditions at lower exposure limits simultaneously can produced disastrous results. Figures 5, 6, and 7 show layout and construction of the HAST boards.

Figure 5. A photograph showing an assembled HAST board.

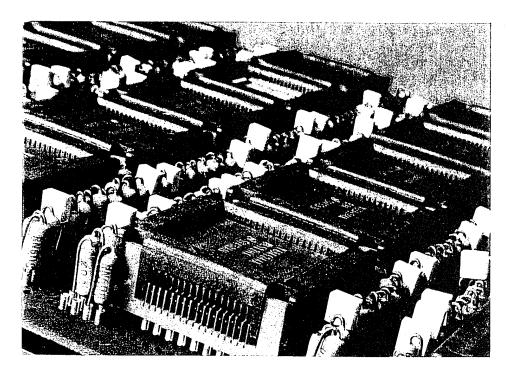
Figure 6. A close-up photograph showing the socket and discrete components of an assembled HAST board.

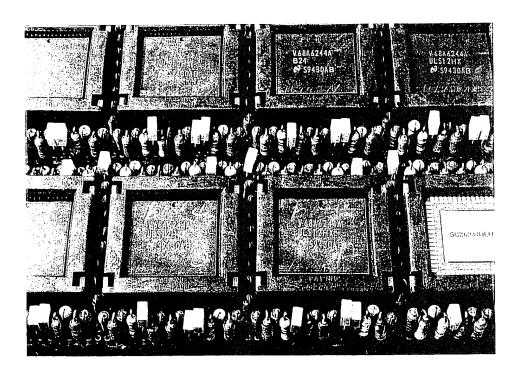
Figure 7. A close-up view showing the component density of an assembled HAST board.

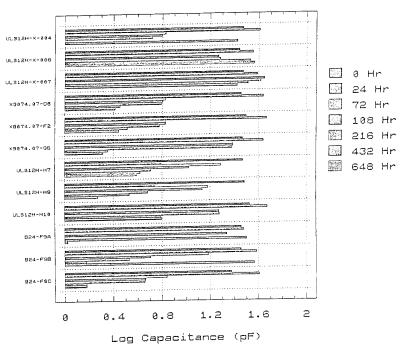
Figure 10. Cumulative capacitance measurements of MSI unpassivated moisture sensors after 157 °C HAST exposure.

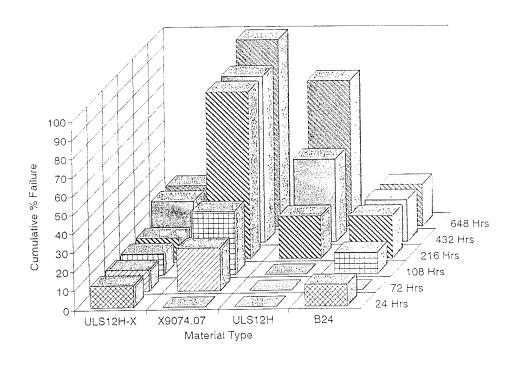
The triple-track corrosion sensors, shown in Figures 14 and 15, revealed more information. The track resistances decayed to opens very rapidly (most of the unpassivated ones within the first 24 hours). The highest rate of failure was the X9074.07 molding compounds in both the unpassivated and passivated cases. The B24 and the ULS12H-X compounds showed the slowest rate of failure.

Figure 14. Cumulative resistance failures of unpassivated triple tracks after 157 °C HAST exposure.

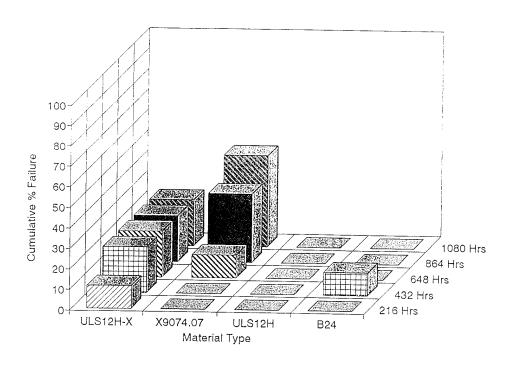
The triple-track measurements, shown graphically in Figures 20 and 21, of the unpassivated sensors rapidly decayed to opens within the first test interval (216 Hrs.). The passivated sensors with the X9074.07 and the ULS12H-X compounds had the highest failure rates.

Figure 20. Cumulative resistance failures of unpassivated triple tracks after 130 °C HAST exposure.

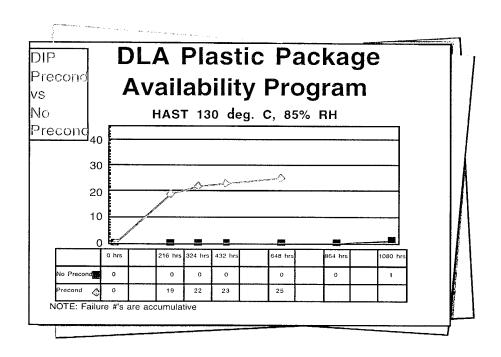
Figure 4 is a chart showing the comparison between the failures of the DIP preconditioned devices and the DIP non-preconditioned devices in 130 degree HAST. The preconditioning tests are performed to simulate manufacturing stresses that the plastic components will encounter. These preconditioning flows are the ones used by National for their commercial components. The DIP devices and the SOIC devices were preconditioned as shown in figure 5.

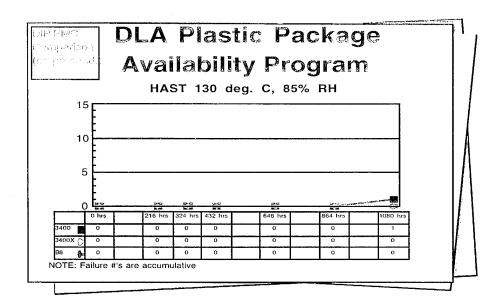
Figure 6 shows a test results comparison between the EMCs used in the DIP package style with no preconditioning tested in HAST at 130 degrees C. As can be seen after 864 hours of HAST, there were no failures that could help distinguish between the three different EMCs. This was one of the reasons for selecting a series of HAST tests at 159 degrees C, to further accelerate the failure to help evaluate the plastic ICs in a more timely manner.

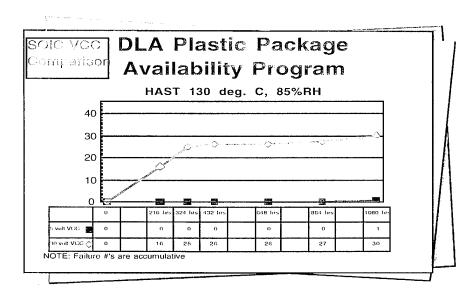
Figure 7 is a comparison of the 130 degree C HAST, 85% RH, SOIC package style, 5 volts VCC versus 30 volts VCC. As can be seen the 30 volts VCC fails sooner than the 5 volt VCC. The 30 volt VCC is within the operating range of the LM124 device.

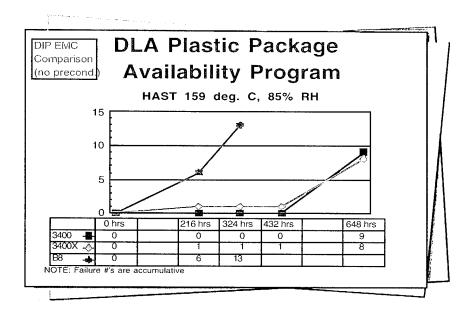
Figure 8 shows a comparison of the three EMCs used in the DIP package with no preconditioning at 159 degrees C HAST. The older National B8 EMC failed first with the Plaskon 3400 lasting much longer. The Plaskon 3400X enhanced EMC show a slight improvement over the 3400 and is much better than the B8. All three preconditioned DIP test lots had reached at least 50% failure at the first data point of 216 hours.

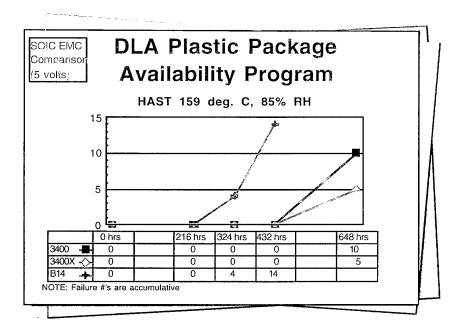
Figure 9 is a comparison of the three EMCs used in the SOIC package at 5 volts VCC at 159 degrees C HAST with 85% RH. The older National B14 SOIC EMC failed first with the Plaskon 3400 lasting much longer. The Plaskon 3400x enhanced EMC shows a marked improvement over the 3400 and is much better than the B14. All three of the SOIC test lots at 30 volts VCC had reached at least 50% failure at the first data point of 216 hours.

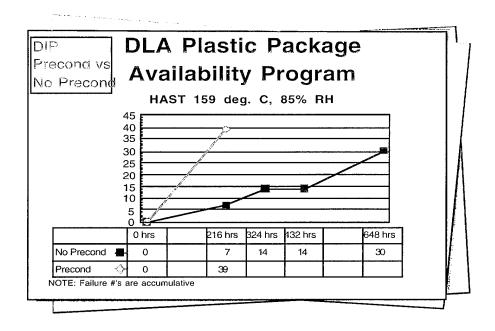
Figure 10 is a comparison of the three DIP lots that were preconditioning versus the three DIP lots that were non-preconditioning at 159 degrees HAST with 85% RH. As can be seen from the test results preconditioning can make a significant difference in the HAST test results. At the time this report was being prepared we do not fully understand the cause of the accelerated failures of the preconditioned devices. A customer buying PEMs should be aware of the type of preconditioning tests that are performed on the devices that they will be purchasing.

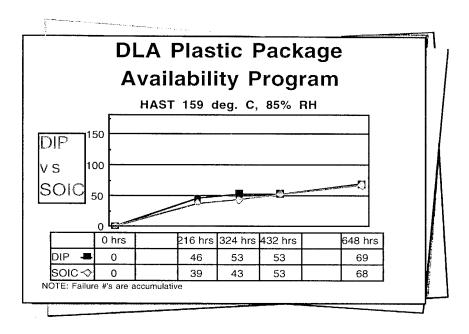
Figure 11 compares the total number of failures of the DIP package versus SOIC package types in 159 degree HAST with 85% RH. This includes 90 DIP devices and 90 SOIC devices for a total of 180 devices. As can be seen from the chart, the package style, at least in this case, did not effect the HAST failure rates. This may not be true for all package styles and should be another factor that the PEM customers must be aware of.

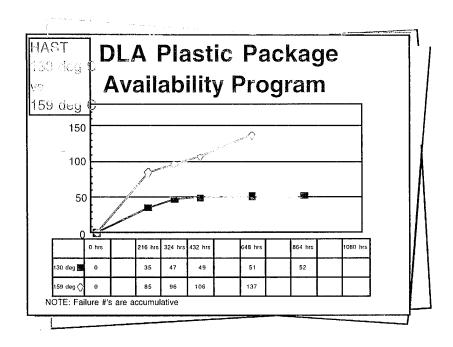
Figure 12 compares the total number of 130 degree HAST failures (out of 180) to the total number of 159 degree HAST failures (out of 180) with 85% RH. Naturally the 159 degree HAST failure rate is higher than the 130 degree HAST but not as high as some acceleration factors would indicate with the 29 degree C temperature difference.

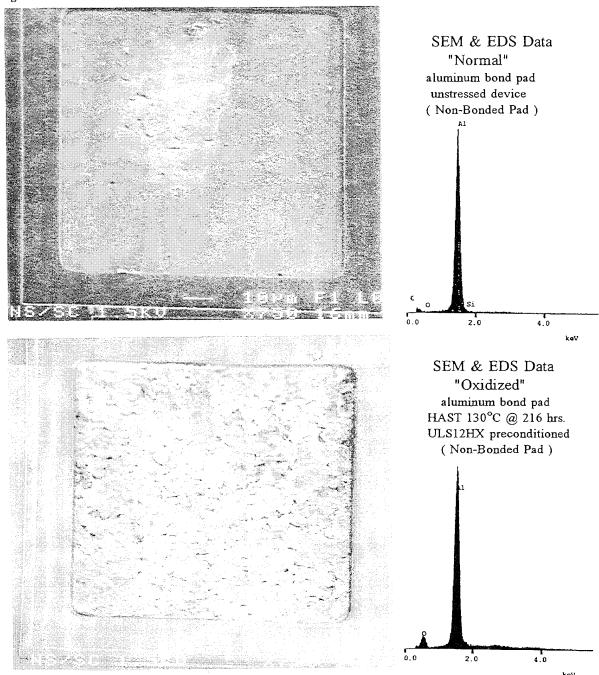
Figure 7 shows the typical surface of the aluminum bond pads from preconditioned 130°C HAST failures @ 216 hours. The SEM/EDS data indicates that the bond pads have oxidized.

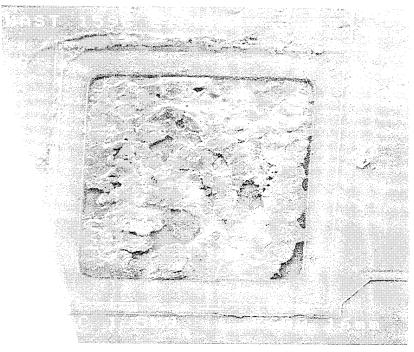
Figure 8

Plastic packages molded with ULS12H, X9074, and B24 were processed through F/A as shown in figure 4. Ball shear data for packages which failed 159°C HAST @ 72 hours are listed in Table 1. SEM inspections on preconditioned 159°C HAST failures revealed several corroded aluminum bond pads (figure 8). The EDS data is shown in figure 9.

Corroded Aluminum
Bond Pad
HAST 159°C @ 216 hrs.
X9074 # 15 preconditioned
(Non-Bonded Pad)

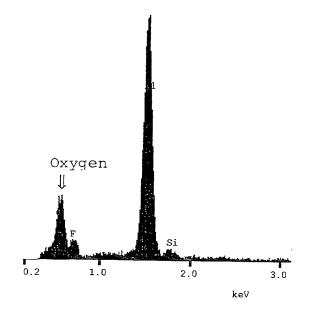
Figure 9

EDS Data
Corroded Aluminum
Bond Pad
HAST 159°C @ 216 hrs.
X9074 # 15 preconditioned

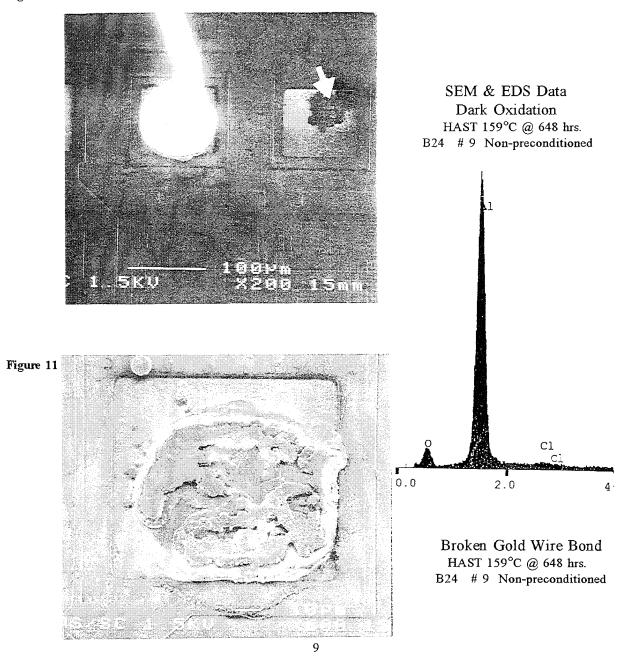
Figure 10

Plastic packages molded with ULS12HX and B24 were processed though F/A as shown in figure 4. The first failures from non-preconditioned 159°C HAST occurred at 648 hours. Typical SEM/EDS data for non-preconditioned 159°C HAST failures are shown in figure 10. Note the dark oxidized material on the aluminum bond pad in figure 10. The fracture surface of a broken gold wire bond is shown in figure 11. Note that part of the aluminum bond pad has been removed. This was the only wire bond that was separated from the bond pad. Three out of five failed devices had broken bonds. The jet etch used in our F/A rarely removes reliable wire bonds.

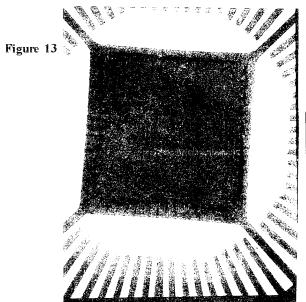
Plastic packages molded with ULS12H, ULS12HX, X9074, and B24 were processed through F/A as shown in figure 4. CSAM was performed on 12 parts (ULS12H) that failed @ 2000 cycles. (see figure 12) Note: All 12 failed devices show delamination.

CSAM After 2000 Temperature Cycles ULS12H (6 of 12 failures)

Bottom View Note: delamination

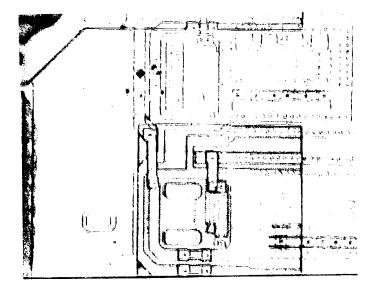
KOH Etch No Passivation Cracks @ 2000 Temperature Cycles X9074 Vss Pin 45

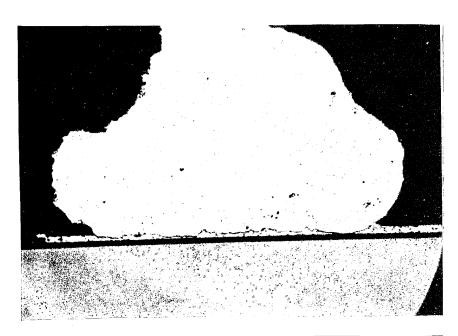
Figure 16

Cross-Section
Through Gold
Ball Bond
unstressed sample
0 Hours HTS 175°C
Non-Preconditioned
ULS12H

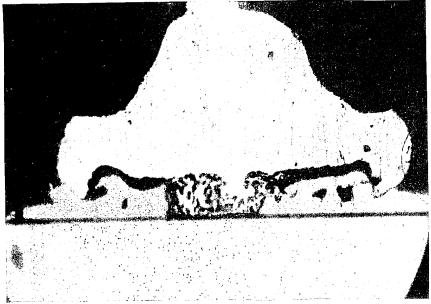
Figure 16 shows the metallographic cross-sections of two gold wire bonds. Staining techniques delineated several intermetallic phases.

Cross-Section
Through Gold
Ball Bond
Intermetallic Growth
4125 Hours HTS 175°C
Non-Preconditioned
ULS12H

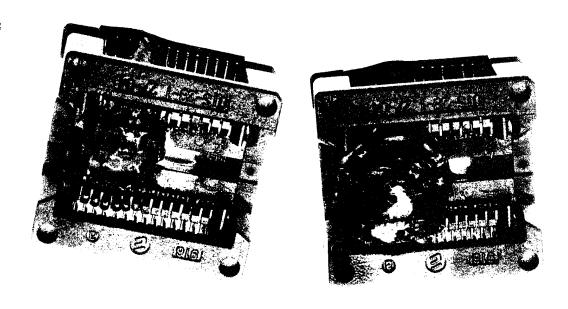
Figure 18

Plastic packages molded with 3400, 3400X, and B14 were processed through F/A as shown in figure 4. Two plastic packages experienced thermal runaway during HAST testing-see figure 18.

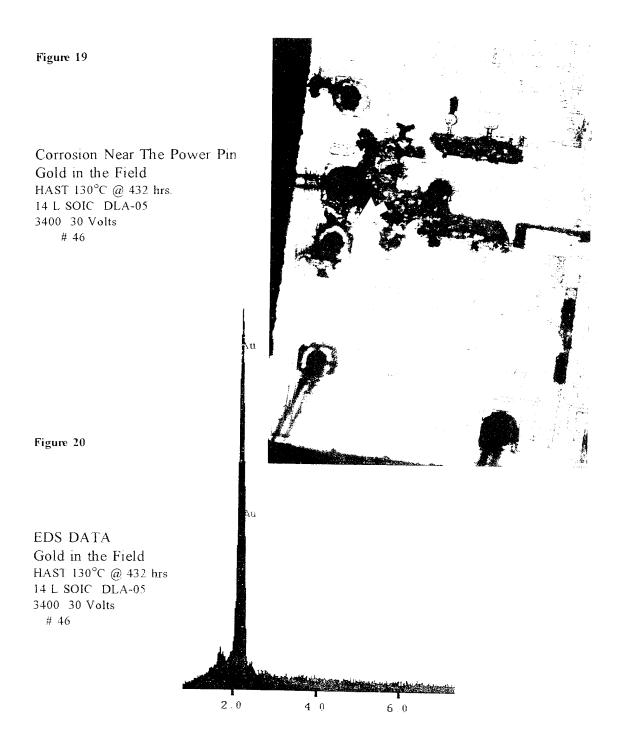
Figure 19 shows the typical surface of a failed device. Optical inspections and SEM/EDS data indicate that there is cracked passivation, broken silicon, and corroded aluminum concentrated near the power pin bond pad. In addition, there is evidence of anodic gold dissolution, stemming from the power pin bond pad. The EDS data is shown in figure 20

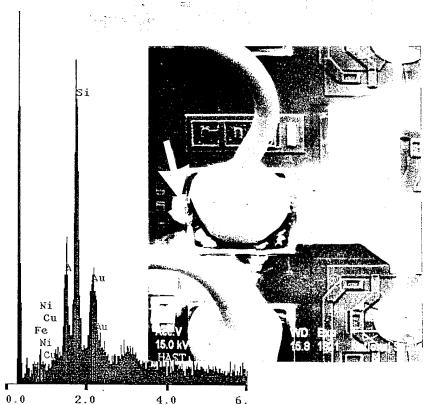
SEM & EDS DATA Gold in the Field HAST 130°C @ 324 hrs. 14 L DIP DLA-02 3400X Preconditioned # 51

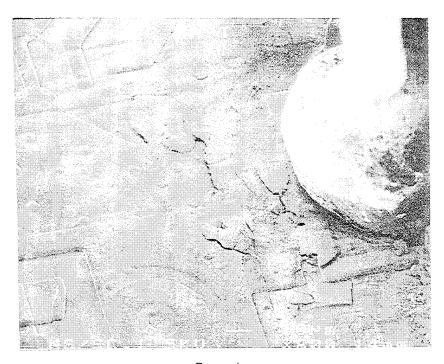
Figure 23

Plastic packages molded with 3400, 3400X, and B14 compounds were processed through F/A as shown in figure 4. Two plastic packages were decapped and inspected. Power pin corrosion was noted on both samples (see figure 23). Packages molded with B14 compound failed at 324 hours. Packages molded with 3400 and 3400X compound failed at 648 hours.

Corrosion
HAST 159°C @ 324 hrs.
14 L SOIC DLA-06
B14 5 Volts
3

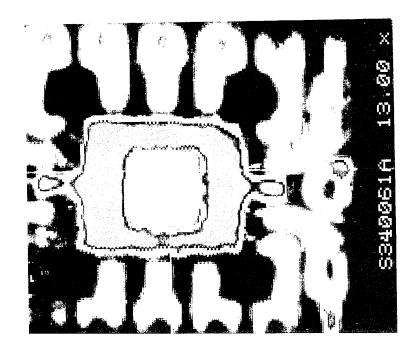
Figure 24

Plastic packages molded with 3400, 3400X, and B14 compounds were processed through F/A as shown in figure 4. CSAM images are shown in figure 24. CSAM images of B14 and 3400X mold compounds show signs of paddle delamination after 216 hours of 159°C HAST.

CSAM Image Delamination HAST 159°C @ 216 hrs 14 L SOIC DLA-06 B14 30 Volts

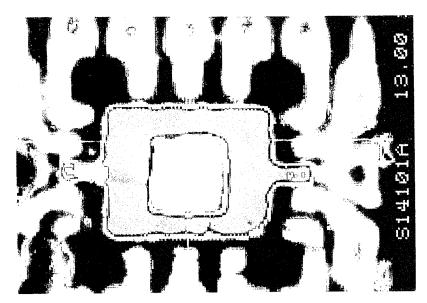
CSAM Image Delamination HAST 159°C @ 216 hrs 14 L SOIC DLA-04 3400X 30 Volts

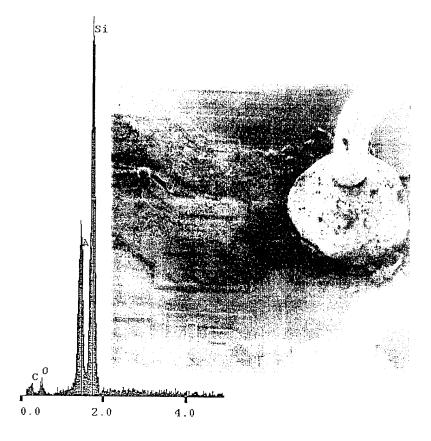
SEM & EDS Data Corrosion HAST 159°C @ 216 hrs. 14 L SOIC DLA-05 3400 # 19 30 Volts

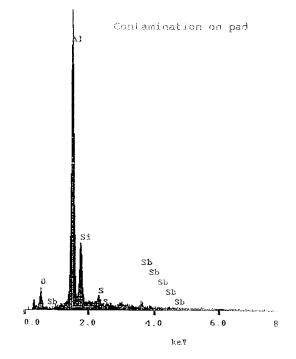
Corrosion Near The Power Pin HAST 159°C @ 216 hrs. 14 L SOIC DLA-04 3400X # 29 30 Volts

EDS Data
Antimony Peak
HAST 159°C @ 216 hrs.
14 L SOIC DLA-04
3400X # 29 30 Volts

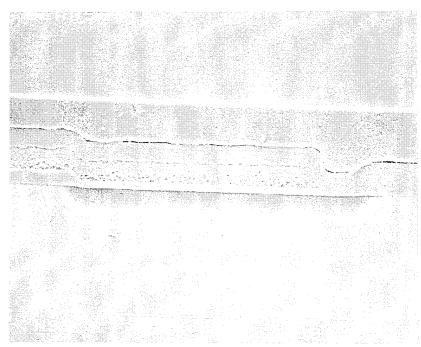
Cross-Section Non-Corroded Pad HAST 159°C @ 216 hrs. 14 L SOIC DLA-05 3400 # 19 30 Volts

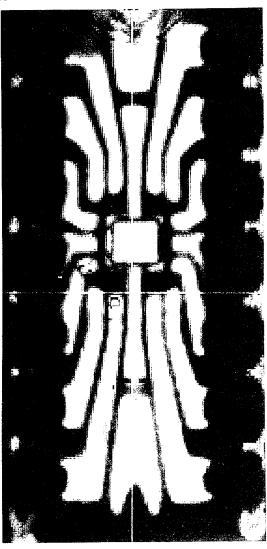
Figure 29

Plastic packages molded with 3400, 3400X, and B8 compounds were processed through F/A as shown in figure 4. CSAM images are shown in figure 29. CSAM images of B8 and 3400 mold compounds show signs of delamination after 216 hours of 159°C HAST.

CSAM Image 159°C HAST @ 216 hrs. 14L DIP DLA-03 B8 Preconditioned Note Delamination Shown in red

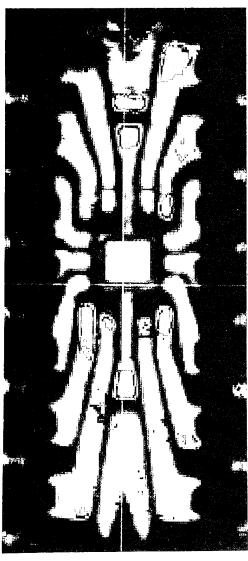
CSAM Image 159°C HAST @ 216 hrs. 14L DIP DLA-01 3400 Preconditioned Note: Delamination Shown in red

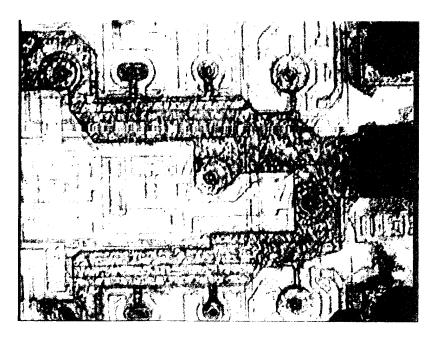
Figure 30

Optical photographs of two failed devices are shown in figure 30. Note the extreme surface damage near the power pin and adjacent field area

Corrosion Near The Power Pin 159°C HAST @ 216 hrs. 14L DIP DLA-02 3400X # 17 Preconditioned

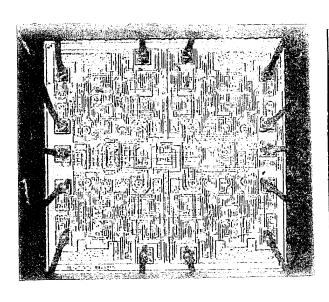
Figure 33

One ceramic failure @ 1080 Cycles: After the lid was removed from the ceramic package, the die was inspected with a high power scope and SEM. The die surface appeared clean and defect free. A photograph showing the field area is shown below (see figure 32). Pull tests were used to check the integrity of the wire bonds. The pull strength results are listed in Table 3. The values listed are within the aluminum wedge bond specification limits. (Normal values ~5 grams) KOH etch was used to check the integrity of the passivation. The results are shown in figure 33.

KOH Etch No passivation damage
